Field Bulletin

- Boot Software Update
- SC66XX US PROM Units

Bulletin #:	FG00606
Bulletin Date:	May 11, 2006
Subject:	Boot Software Update
Affected Model(s):	SC66XX US

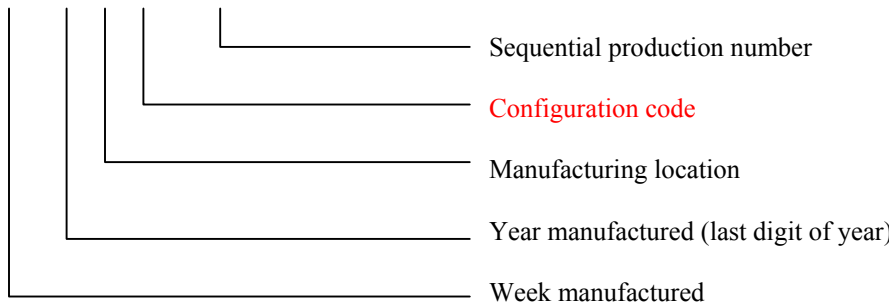
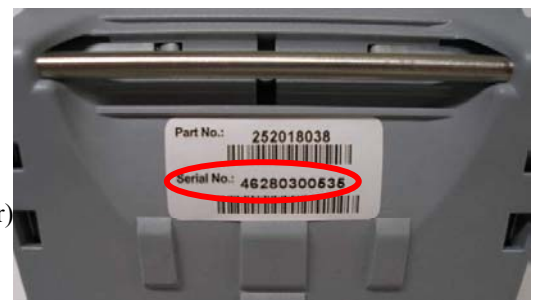
WW Y L CC #####

SC66XX PROM units with Configuration Code 06 or lower indicates that the update is required. The serial number of the Acceptor contains the Configuration Code of the unit. The serial number of the Acceptor Module can be found on the sticker located on the bottom of the acceptor module (See below).

- A MEI or AESI technical representative can only perform this update.
- To have units updated with the latest Boot Software, please contact your local MEI or AESI Technical representative.
